Hubble Space Telescope Servicing Mission Four (HST SM4) EVA Challenges for Safe Execution of STS-125

ABSTRACT

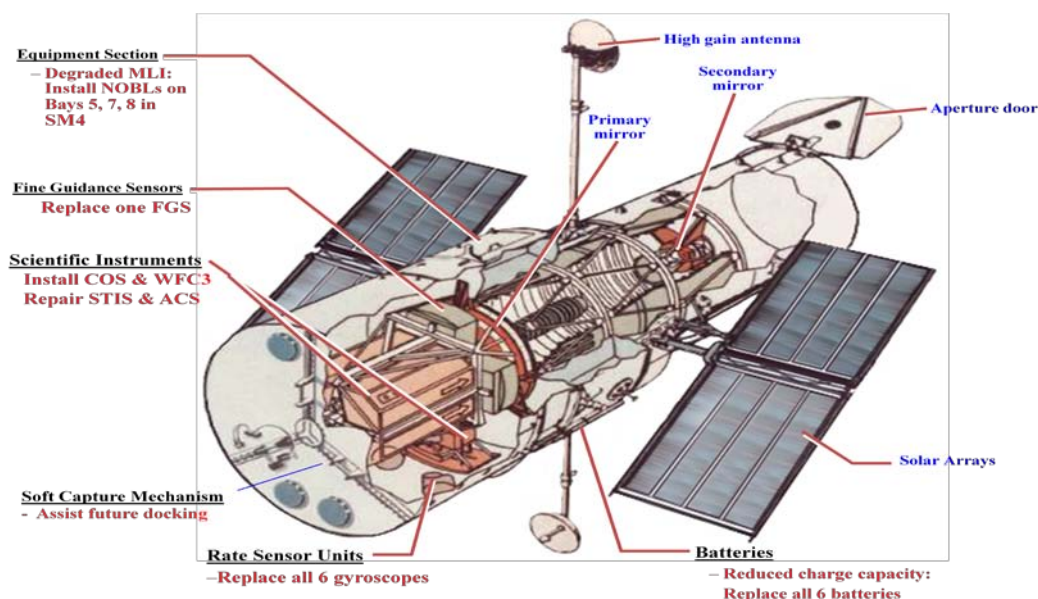
Figure 1. Hubble Space Telescope Replacement Unit

spacecraft subsystems and scientific instruments by servicing. Due to servicing, HST has remained operational and productive over the last 17 years since Servicing Mission 1 in 1993. Prior to SM4, and including SM1, there have been four other visits to the telescope (one servicing mission was broken into two parts due to the extent of the repairs and replacements). Due to the imminent retirement of the shuttle, Servicing Mission Four (4) was the final opportunity to restore and enhance the telescope's capabilities using the orbiter. Fig. 1 provides an outline of HST and summarizes the repairs and replacements made for SM4.

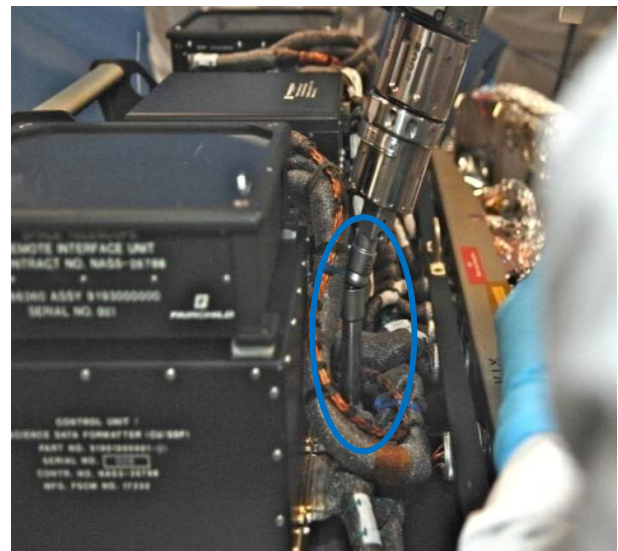
Figure 5. Fit Check on SI C&DH with Power Grip Tool (PGT) and 6" wobble socket extension

The EVA Verification Plan (HST-TR-010303, Appendix D) documented fit checks performed for each tool and interface for both HST and the carriers. Fig. 5 shows a fit check being performed on the Science Instrument Command and Data Handling (SI C&DH) Unit. Verification was provided by reviewing signed-off work orders. The plan identified tool-to-tool fit, with instrument interfaces, translation paths, worksite access, mechanical advantage, and visual cues.

The EVA team conducted fit checks on equipment interfaces with the Go/No-Go Gauge, every possible socket option and extension, and tools in line with the Torque Matrix established by GSFC Mechanical Engineering. For example, all corners of the SI C&DH were evaluated for any interferences and assessed tight clearances. At the pad at the Kennedy Space Center (KSC) after hardware was installed on the stowage carriers, the EVA team verified that setup was in safe configuration for the mission within days of launch during the Payload Walk-down for quality control inspection of the equipment.

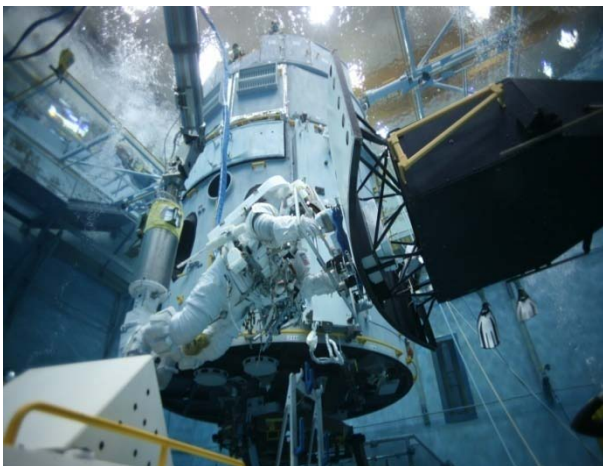
Figure 6. Stowage of WFPC-3 on Aft Fixture at NBL

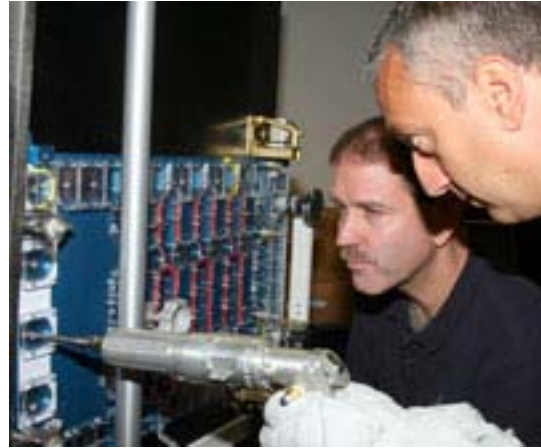
Figure 7. STIS Repair 1-G Trainer with Fastener Capture Plate and Mini-Power Tool

during the mission. Additionally, flight-like simulators were built for tabletop briefings at JSC along with virtual reality mockups to give the crew the best available sense of what it would be like to handle these new instruments and tools on orbit – including fit, form, and function. Fig. 7 shows the crew practicing SM4 activities with mockup trainer.

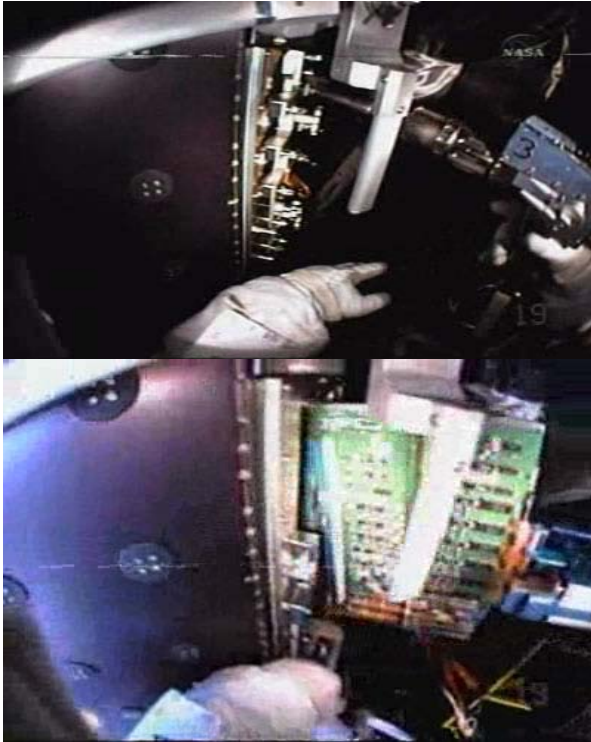
*Figure 8. On-Orbit ACS Repair Photos –
Top: Showing PGT engaging Grid Cutter blade
Bottom: Removing ACS Circuit Card, with tool
protecting crew from contact hazards*
